Property Inspection Report

Property Address: 31415 Da Vinci Lane, San Jose, CA
Type: Single Family Residence
Inspection date: April 13, 2017
Inspected for Client: Jamie Oliver
RE Agent: Stephen William Hawking
Company: Forever Realty
Address/City: 16180 Golden Palace Drive, Cupertino, CA
Inspected by: Chris Kremer, Alex Abreu, or Sean Johnson

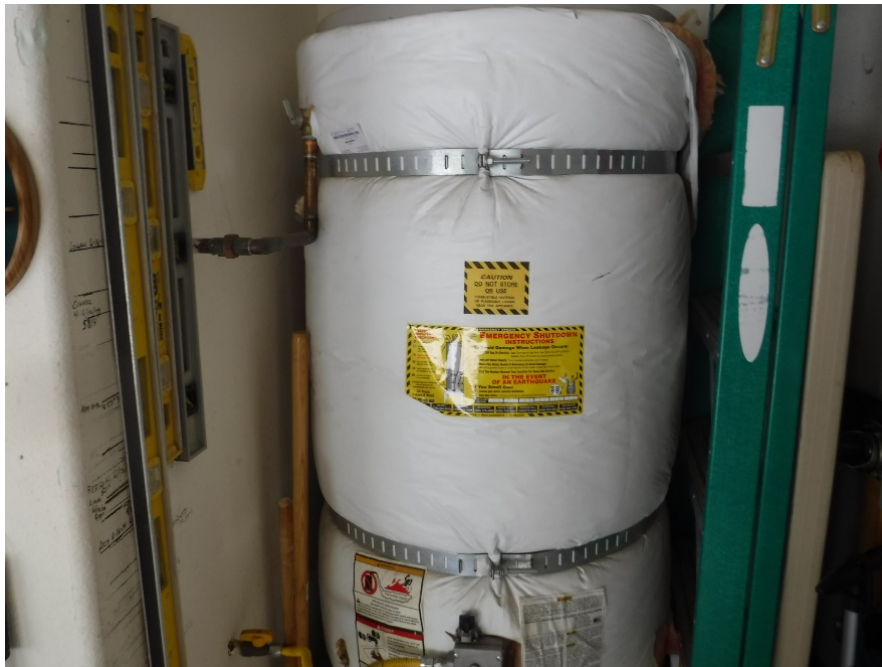
- A. This water heater is strapped by the most popular method, however it is not in compliance with the methods suggested by the Division of the State Architect because it is missing the third strap. SEE PHOTO

It is recommended that a competent plumbing contractor be consulted for recommendations and corrective work.
